Project title Machynys Hotel

Subject Geoenvironmental & Geotechnical Desk Study Note to support the Machynys Hotel
Site Planning Application

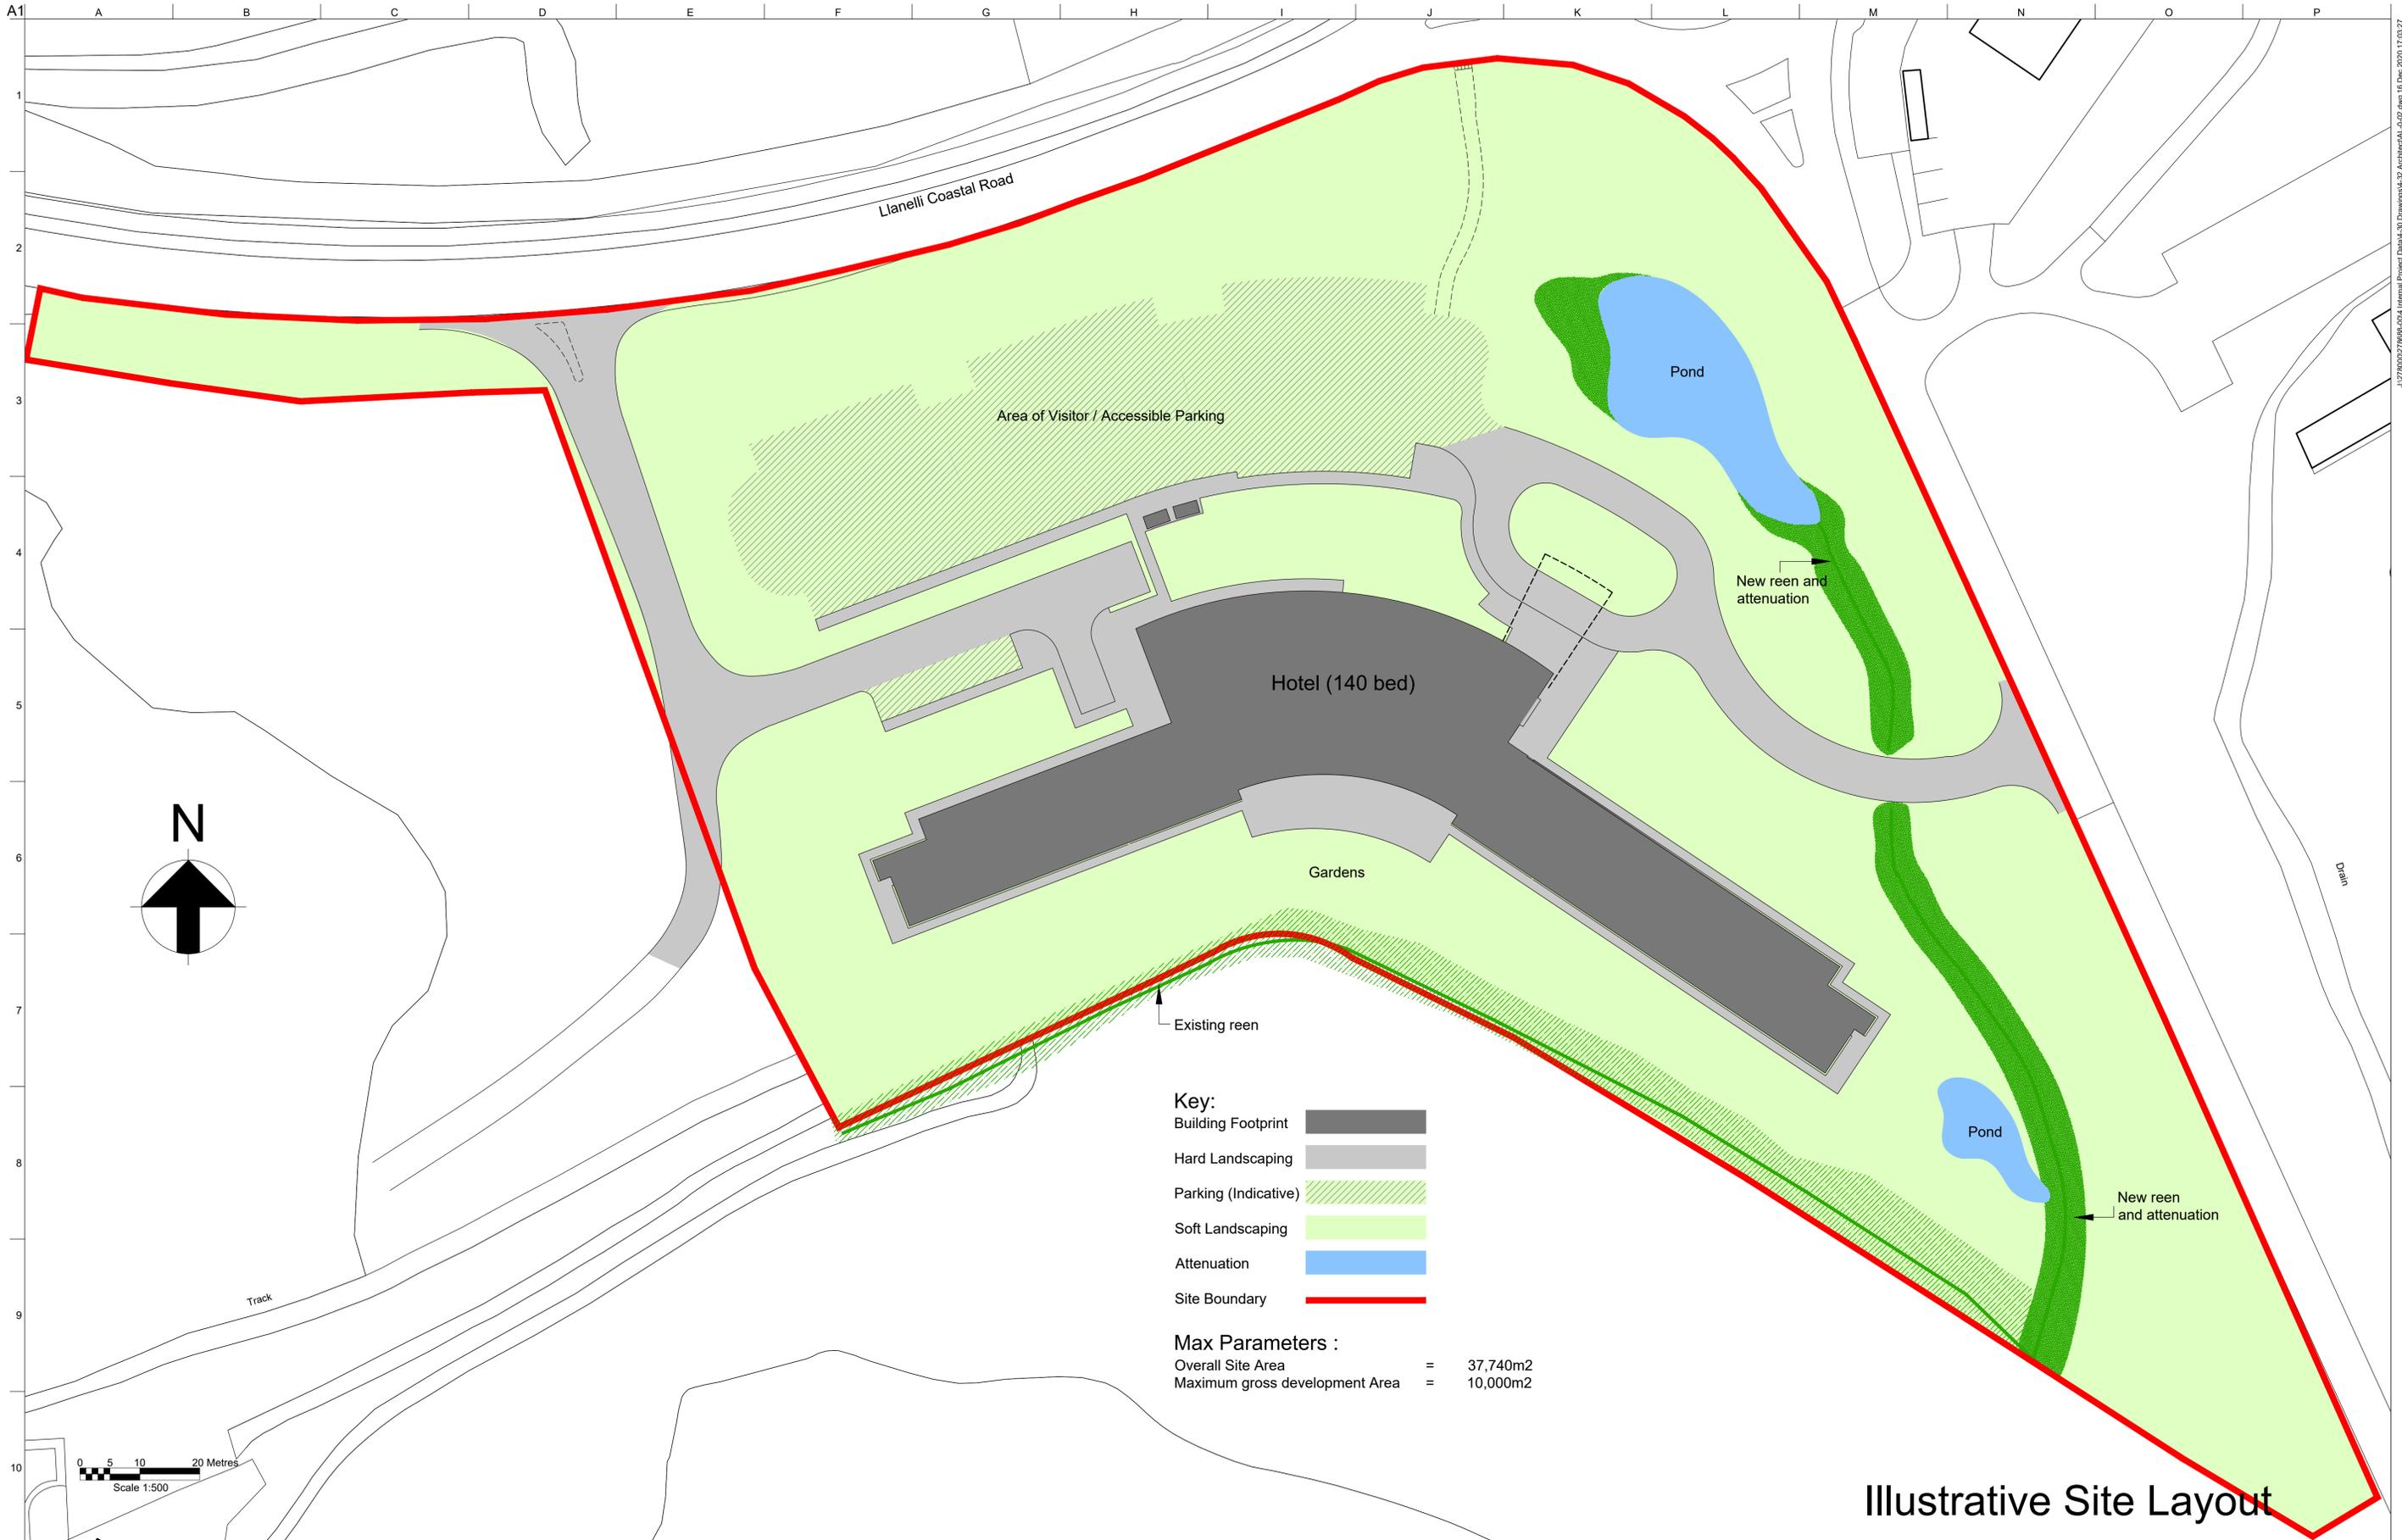
Drawing Title
 Illustrative Site Layout

Building Footprint	
Hard Landscaping	
Parking (Indicative)	
Soft Landscaping	
Attenuation	
Site Boundary

Scale at A1	1:500
Discipline	Architectural
Job No	278688
Drawing Status	Outline Planning
Drawing No	AL-0-02
Issue	P01

An illustrative site layout plan showing the proposed development is shown on Drawing 2.

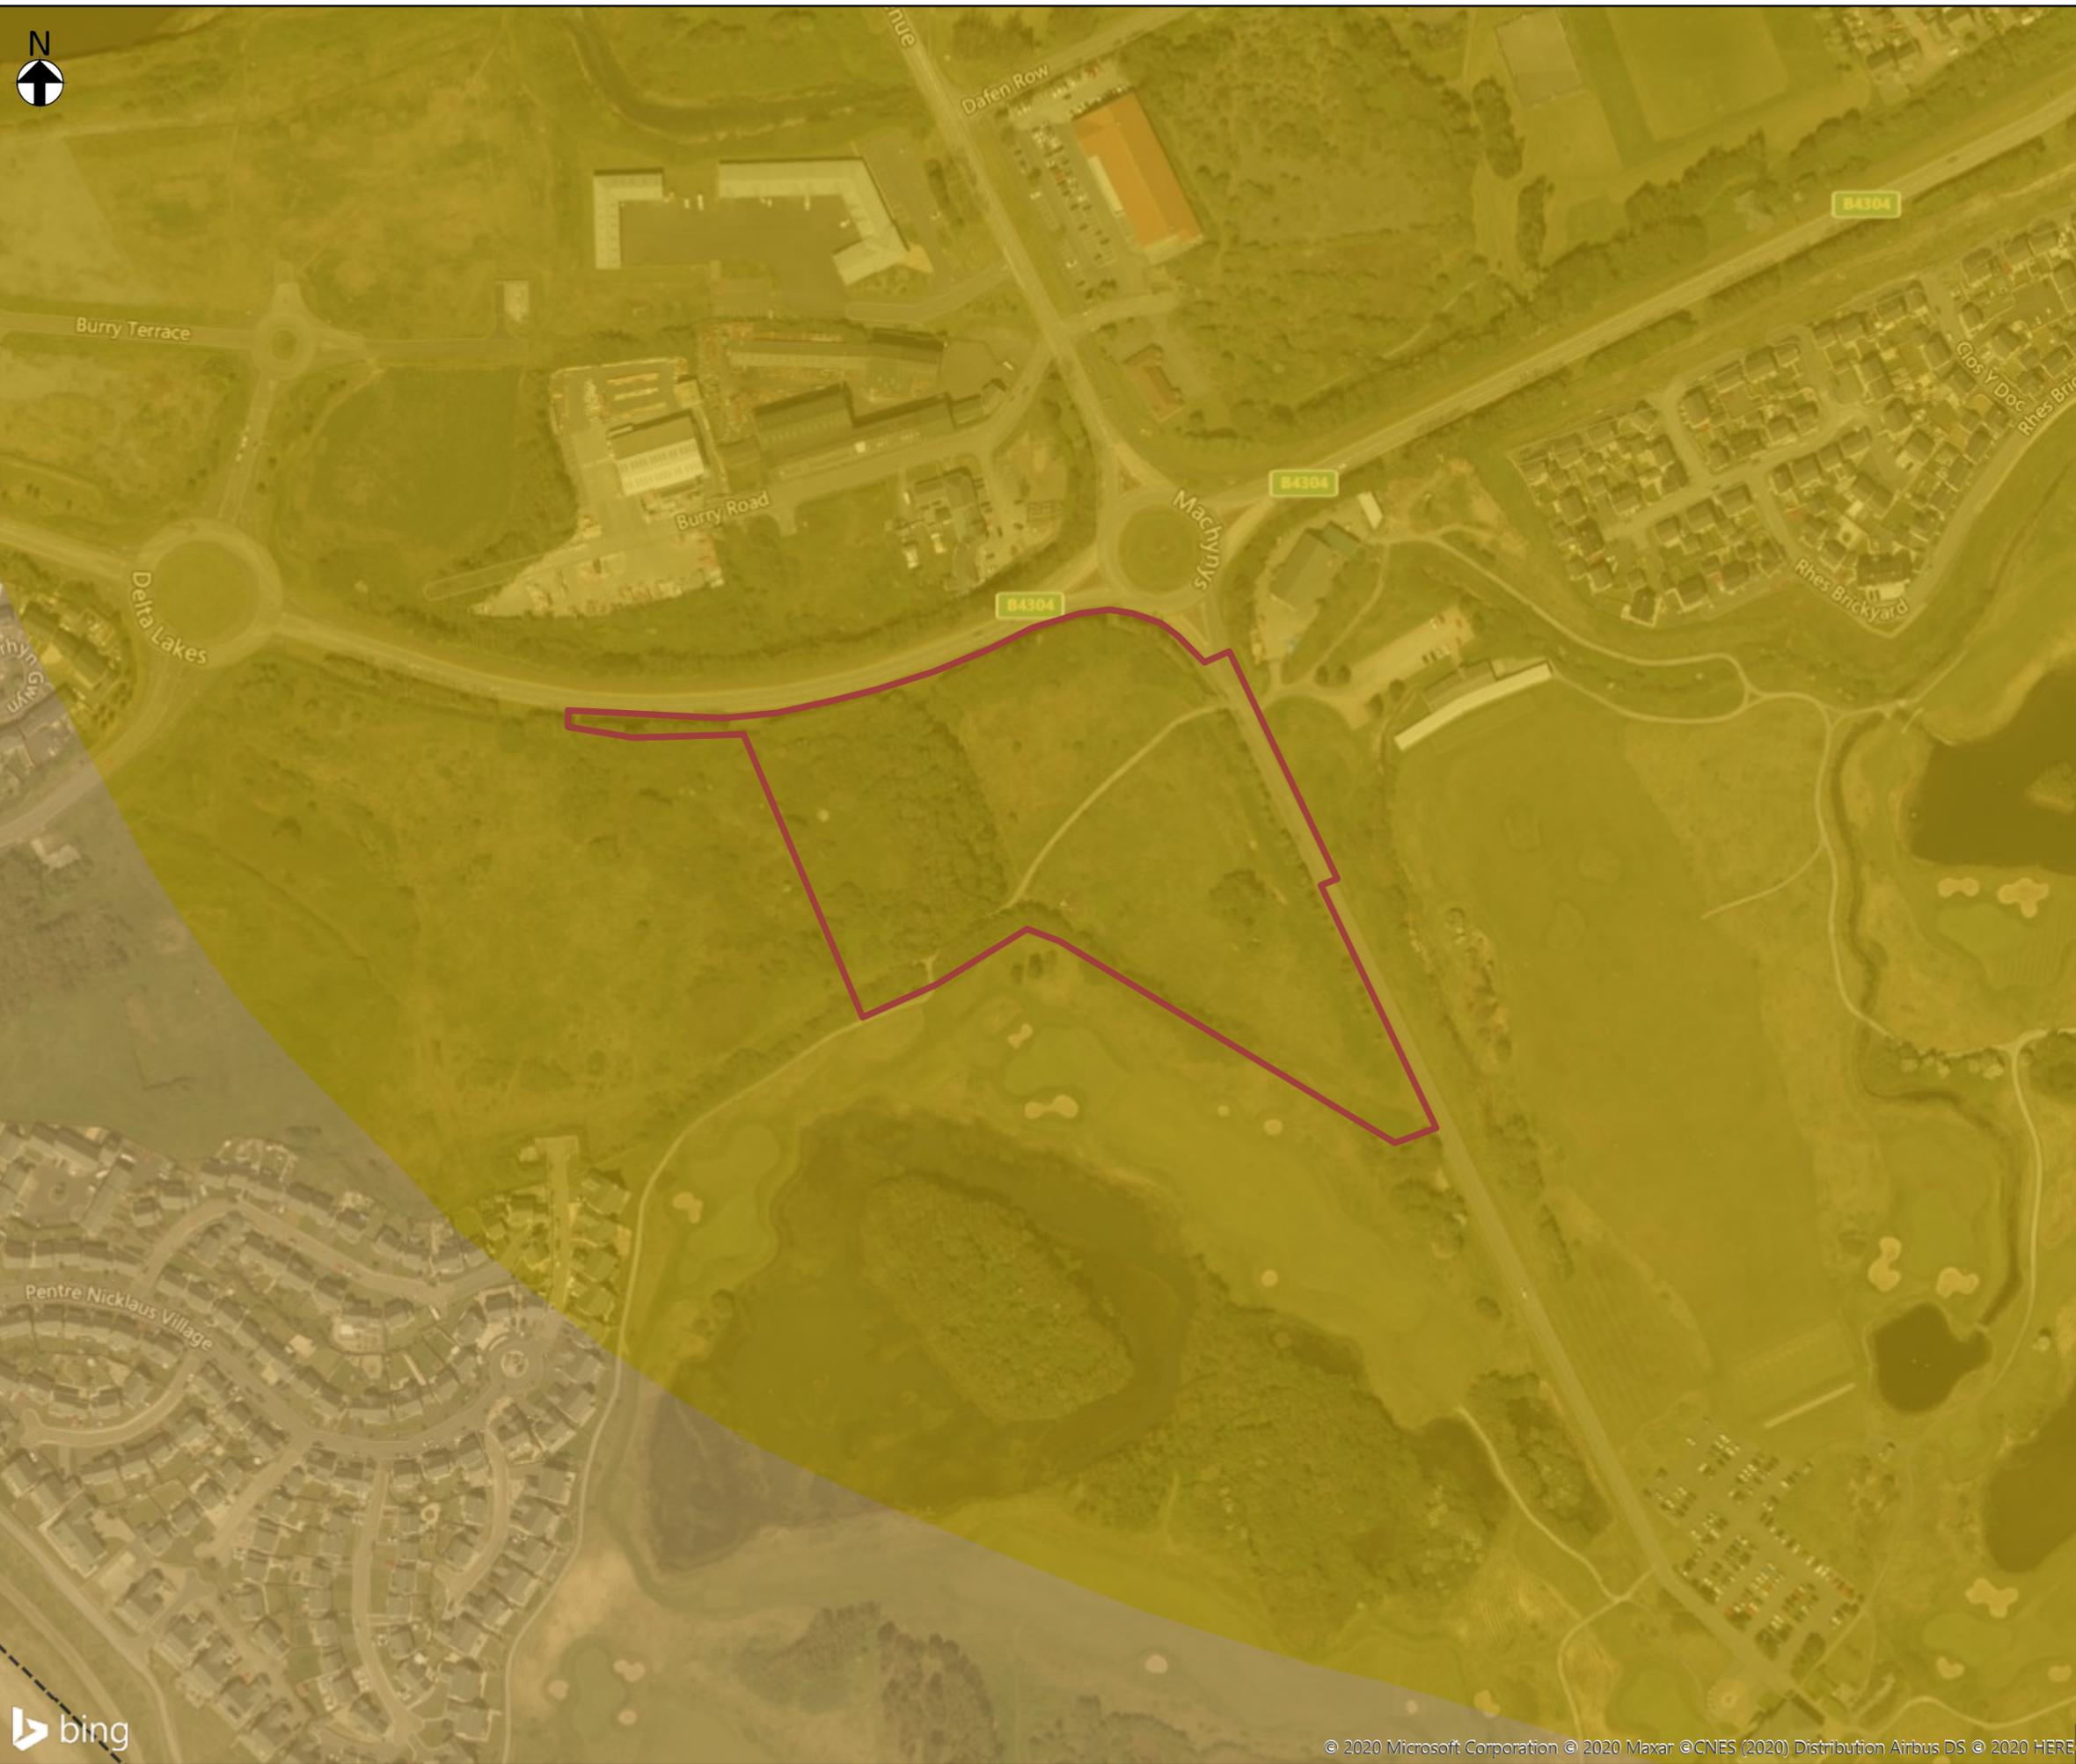
Drawing Number: **5**

- Site Boundary
- Hughes Member - Sandstone
